CONNECTICUT RIVER BASIN
GRANTHAM, NEW HAMPSHIRE

EASTMAN LAKE DAM
NH 00039

PHASE I INSPECTION REPORT
NATIONAL DAM INSPECTION PROGRAM

MAY 1979

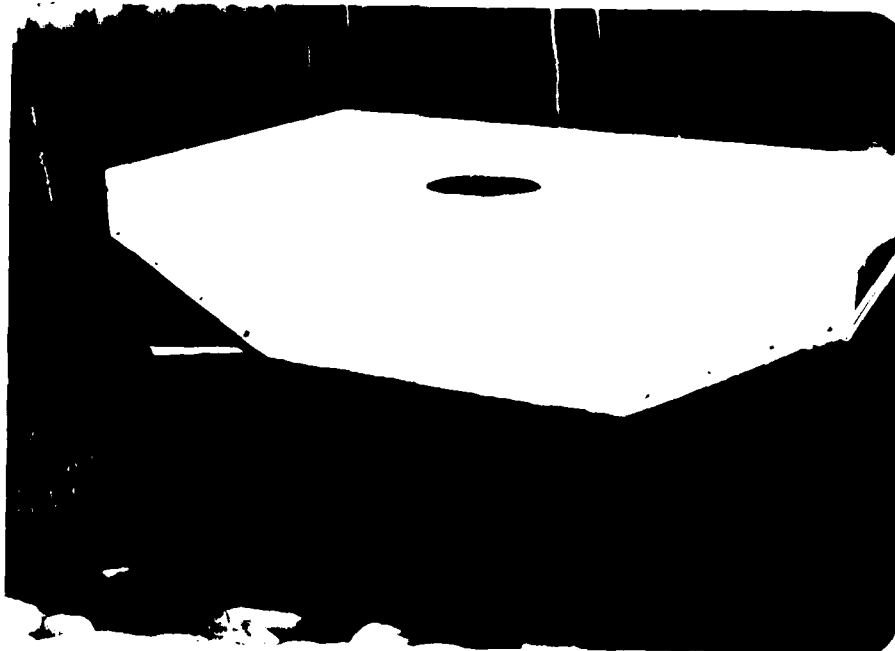
5. Intake Structure: Riser with Two Crests, Looking Northeast.
